# ONGO HOMES - FIRE RISK ASSESSMENT

**Princess House**  
**Market Hill, Scunthorpe, North Lincolnshire,**  
**DN15 6SL**

| ASSESSMENT REF. | 970111 |

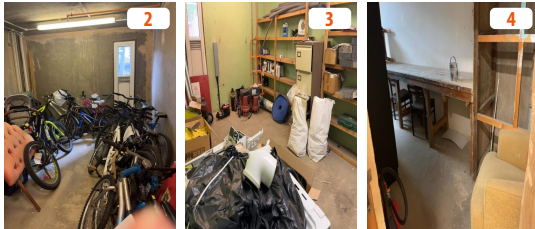
LOCATION Ground floor switchroom.

During the assessment, combustible items and general clutter were observed within the circuit room and ancillary areas, located on the ground floor. The Responsible Person should ensure that all these areas are kept clear of unnecessary materials and combustible storage at all times. Any accumulated items should be removed immediately, and a routine housekeeping inspection regime should be implemented.

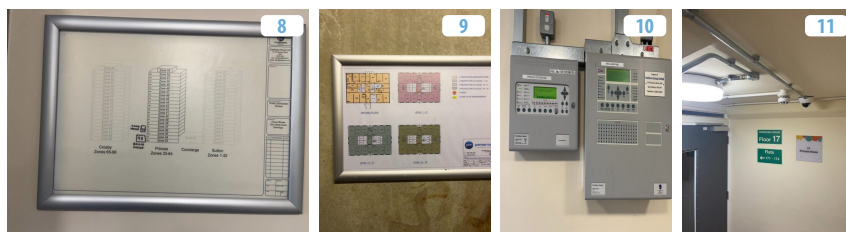
LOCATION Automatic Fire Detection and Alarm System.

The automatic fire detection and alarm system is subject to routine servicing in conformance to BS5839 - 1. The AFD system at this block was last serviced on 14/4/25 by Firestop Services Ltd and this is within the required timescales. However, alarms within individual flats were noted as inaccessible, and no separate maintenance records were available. The Responsible Person should ensure these are included in future inspections to confirm full system coverage and compliance. BS5839 - 1 Fire detection and fire alarms systems for buildings requires that Automatic Fire Detection systems are subject to a routine of 6 monthly servicing.

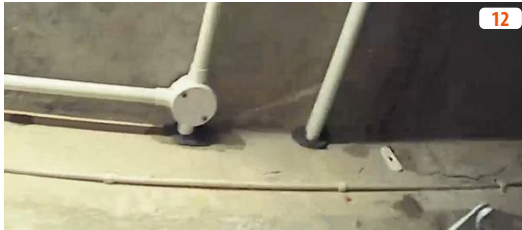
LOCATION Ground floor ancillary rooms.

It was observed that there had been some fire stopping work carried out in various locations around the building. It is recommended that where fire stopping works are carried out, a fire stopping log is maintained which details dates, locations and materials used along with a record of the operative and photographic evidence of work carried out. Information on products used has been provided for this assessment but a fire stopping log has not been seen.

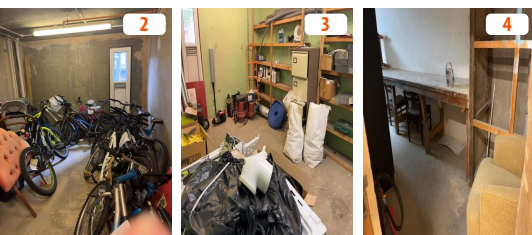
LOCATION Ground floor switchroom.

During the assessment, combustible items and general clutter were observed within the circuit room and ancillary areas, located on the ground floor. The Responsible Person should ensure that all these areas are kept clear of unnecessary materials and combustible storage at all times. Any accumulated items should be removed immediately, and a routine housekeeping inspection regime should be implemented.

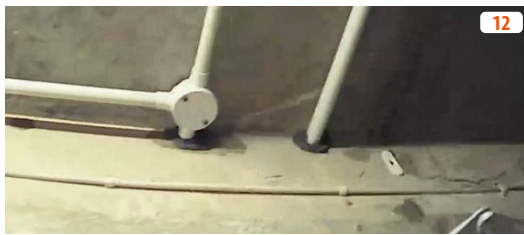
It was observed that there had been some fire stopping work carried out in various locations around the building. It is recommended that where fire stopping works are carried out, a fire stopping log is maintained which details dates, locations and materials used along with a record of the operative and photographic evidence of work carried out. Information on products used has been provided for this assessment but a fire stopping log has not been seen.
