# FIRE CONSULTANCY SPECIALISTS LTD

## FCS Residential Template

Crosby House  
Crosby House  
Market Hill  
Scunthorpe  
North Lincolnshire  
DN15 6SG

10 October 2023

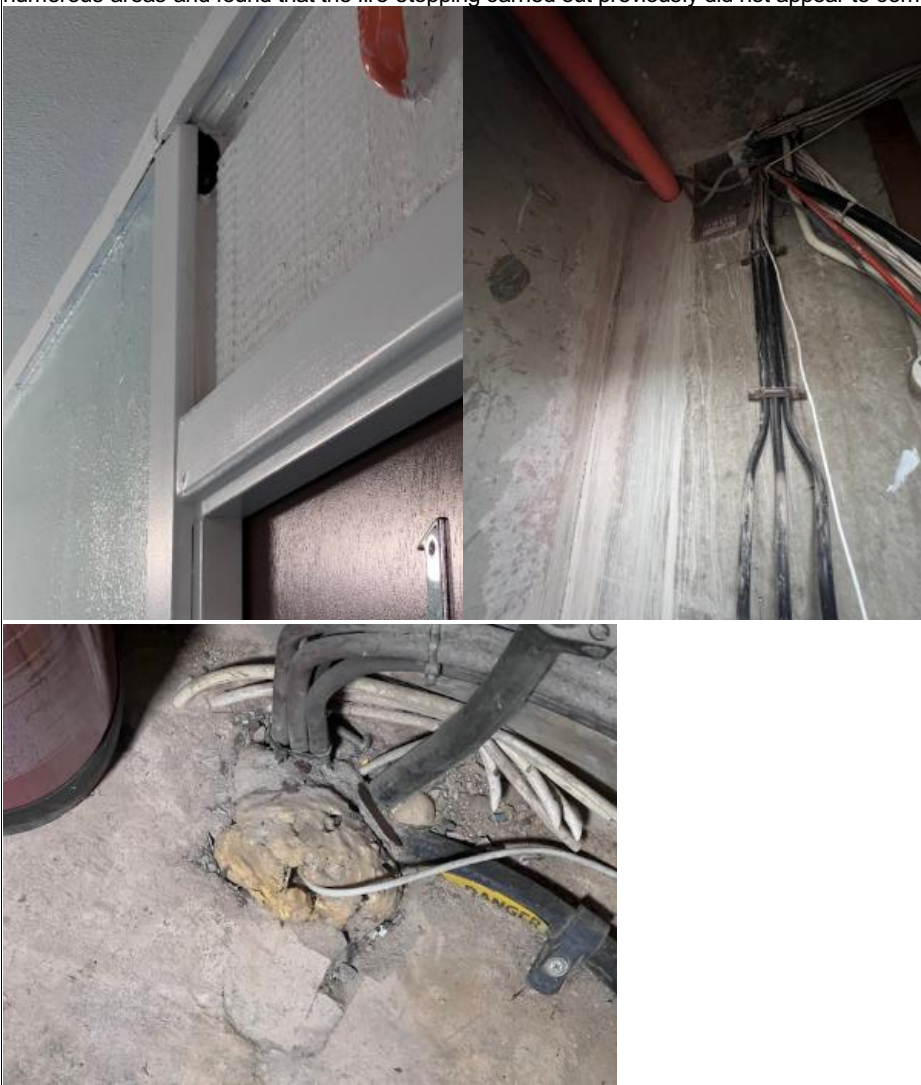
Ref	SIGNIFICANT FINDINGS
	<b>Observation</b>
9.5	<p>An ad-hoc survey carried out by both the fire risk assessor and a colleague from the passive fire protection team inspected numerous areas and found that the fire-stopping carried out previously did not appear to comply with industry best practice.</p>

<b>Recommended Actions</b>
9.5	Recommend that a complete compartmentation and fire stopping survey is carried out in these premises.
Ref	RECOMMENDATIONS
	None.
Ref	COMMENTARY
	None.

9.5	An ad-hoc survey carried out by both the fire risk assessor and a colleague from the passive fire protection team inspected numerous areas and found that the fire-stopping carried out previously did not appear to comply with industry best practice.	Recommend that a complete compartmentation and fire stopping survey is carried out in these premises.	P1	Tolerable		10 Oct 2024
